Visual Inspection Images

This document is prepared to demonstrate some of the capabilities of CIA's Remote Visual Inspection Service. At the same time, we hope that users of this document will be able to relate their own visual inspections with many of the conditions that we have documented.

The following images are typical of the images found during CIA Inspection's remote visual inspection segment of the coke drum inspection. Due to the image transfer from SVHS tape to digital media, the resolution and sensitivity of the taped images are reduced. Note that the elevation and azimuth are permanently recorded on the videotape.

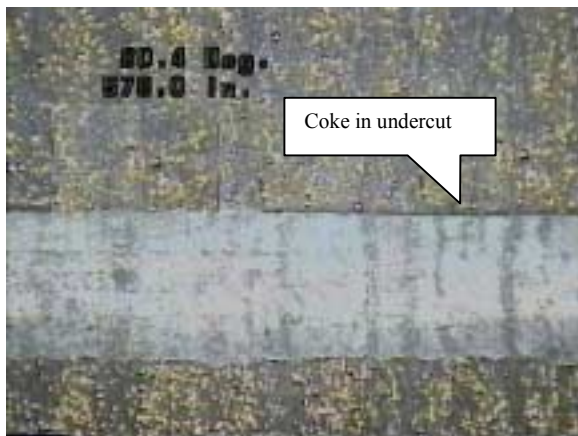
Image 1 is a flush ground weld in an eight-year-old drum. The weld metal is Inconel and the clad on the parent metal is 410 stainless steel. The weld metal clearly contrasts against the parent material. This is typical in well washed in service drums.

Note the dark line along the upper toe of the weld. This is residual coke from the wash collecting in a slight undercut. This area is adjacent to a crack site. Care has to be taken in interpreting this condition.

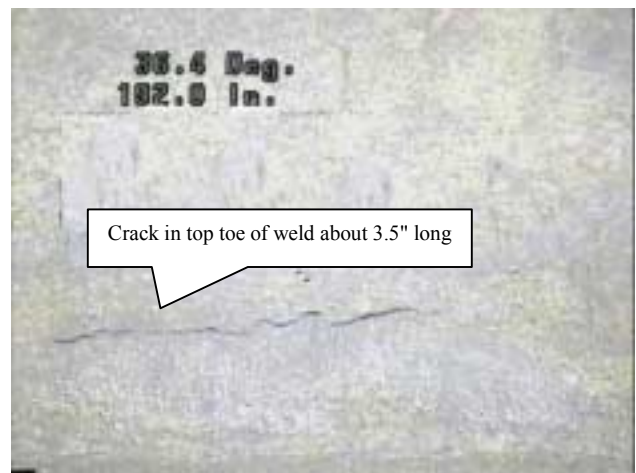
Image 2

This image shows a very prominent crack in the top toe of the weld and is 3.5" long. Ultrasonic evaluation determined this crack to be 0.328" deep extending at least 0.250" into the pressure boundary.

The owner is monitoring this crack ultrasonically during operation to prevent a through wall failure and to allow operation until the next turn around. This crack type indication is typical of those found at shell thickness transitions in alloy drums. They are most commonly found in the upper heat affected zone at thickness.

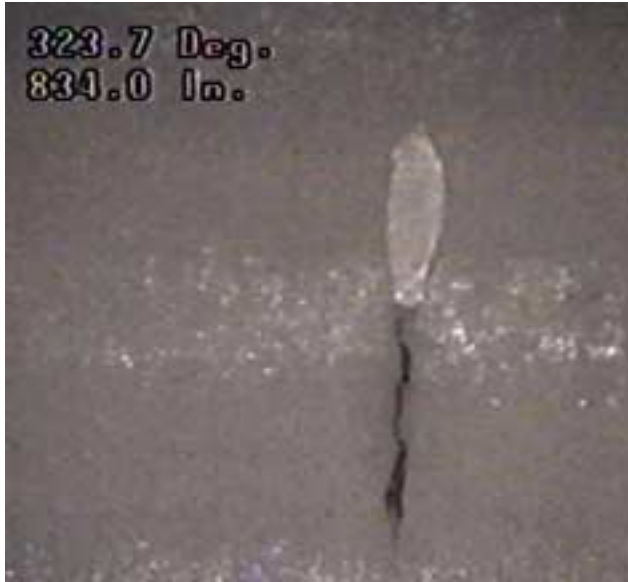
Image 3

This image shows a vertical crack extending from a cladding repair. This type of indication initiated and extended from a construction false work repair. These types of repairs are common in field erected drums.

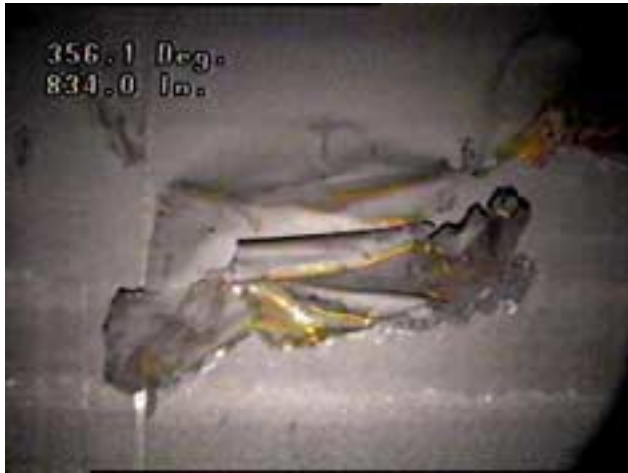
Image 4

This illustrates delamination of a fusion-bonded cladding. This condition first appears as blistering. The delaminated area will propagate to the point where the clad is fused. Delamination of spot welded liners is more extensive starting with cracking around the spot welds and eventually breaking away between the spot welds or at the liner butt welds. Spot welded liners are seen in older carbon steel drums.

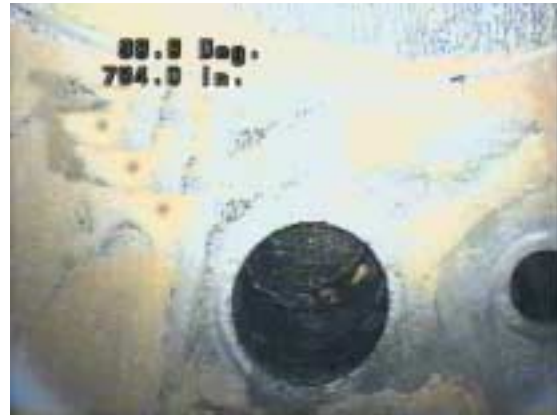
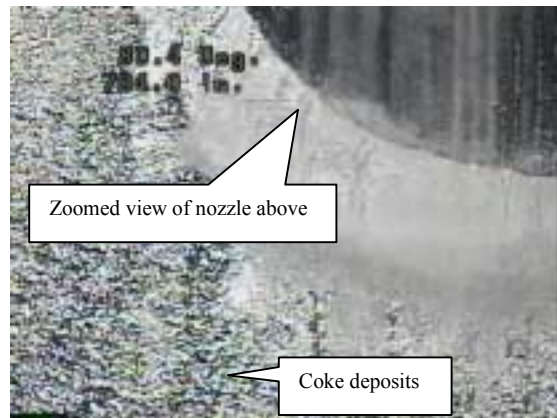
Image 5

These are images of nozzles in the dome section. Nozzles can be viewed for coking and if the nozzle to shell weld is clean this area can be viewed for in-service anomalies. The dome section is difficult to clean and is generally covered with a tightly adhering layer of coke

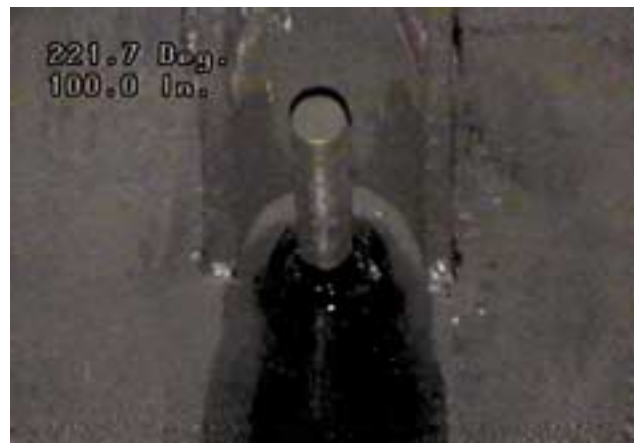
Image 6

Thermalwells and probes can be inspected for cleanliness and condition. In the case of this image, the insert plate welds can be inspected for in-service anomalies.

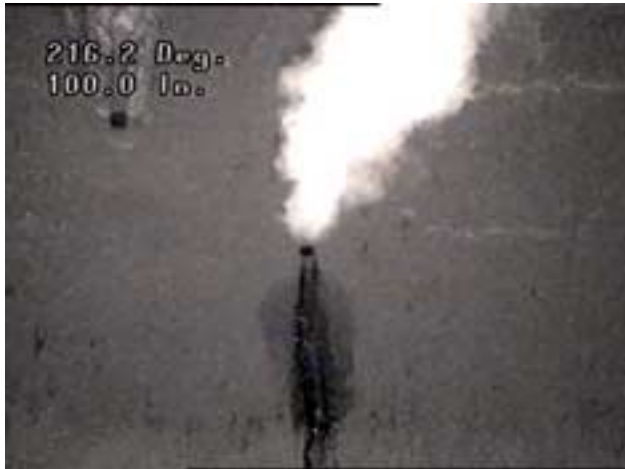
Image 7 shows a steam injector nozzle passing steam with the block valve closed. This is indicative of worn or coked valve seats. This condition can be seen remotely because feed streams do not have to be isolated for remote entry. CIA's drum profiling and video system is housed in a Class 1 Division 2 housing.

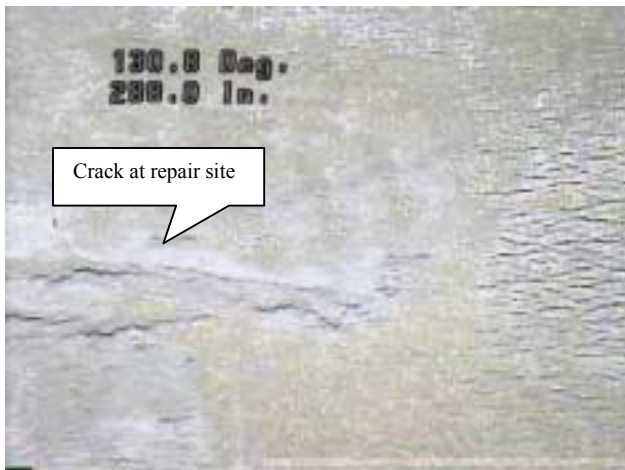
Image 8 shows cracking initiated at a repair site and propagating in the repair and the original weld. The repairs in this image are one year old. Crack initiation in these conditions could be due to non-relevant indications in the repair area, incomplete removal of the original repair indication or metallurgical alteration from excessive thermal input during the repair welding process.

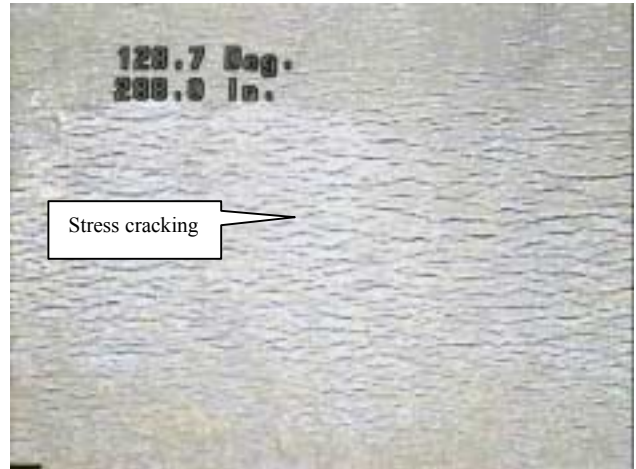
Image 9 shows surface stress cracking in mid course. This stress cracking coincides with a band of outward radial growth (bulging) that has increased by 1" to 2 1/2" over the benchmark scan which was performed 18 months earlier. This radial growth was mapped using CIA's laser profiling instrument. The laser image was used during the remote video inspection to determine the relationship between the dimensional anomaly and the visual anomaly. Transverse cracking can be seen in the vertical weld in a year old repair area in the bulge.

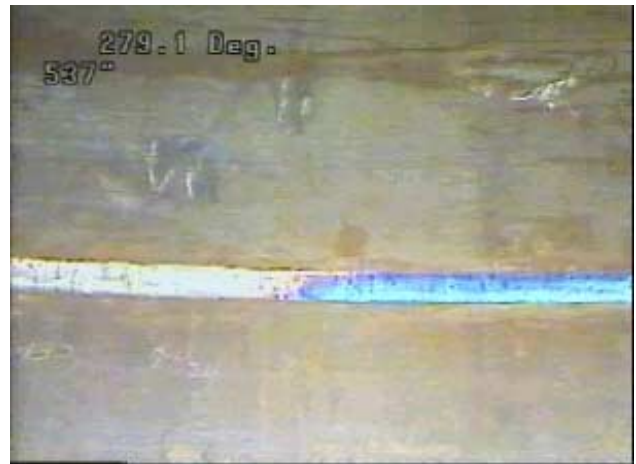
Image 10 is an external weld repair on a new drum post erection and before first fill. The bluing seen in this image is typical of excessive thermal input during a radiographic repair. Exceeding the weld procedure inter pass temperature causes metallurgical alteration outside of the limits of the PQR and WPS. This alteration results in a stress raiser and residual stresses beyond that of the design criteria. Video recording and laser profiling of new drums before going into service provides the user with an opportunity to identify conditions such

as these. Due to the highly cyclical nature of coke drum operations, a record of non-relevant code indications and areas of excessive thermal input and dimensional anomalies help to establish their relationship with failure initiation. It has been noted in CIA's database that there is a repair site and operational failure initiation relationship seen in subsequent scans. This information helps owners and fabricators to refine their construction and repair specifications to minimize operational failures.
