Volume 5, Issue 1

April 2003

# The Profiler

A NEWSLETTER OF INFORMATION FOR COKE DRUM OPERATORS

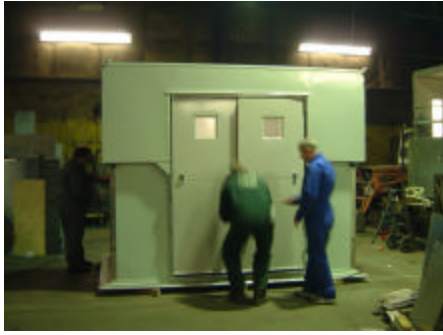
*CIA staff demonstrate it's capabilities*

Similar to the portable control rooms used by CIAI, this innovative container design has an extendible roof which allows the container to meet the 62 inch height requirement during shipping and then raises to 7 ft. 6 inches in the field.

- convenient lifting points makes container ideal for trucking and handling with roller beds, fork lifts or cranes;
- large payload capacity - 4000 lbs.;
- weather tight, secure enclosure complete with windows and locking doors ;
- electrical distribution panel providing HVAC, lighting and power outlets;
- heated & air-conditioned provides a comfortable working environment.

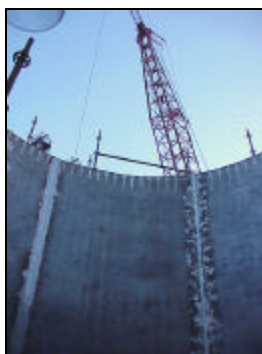
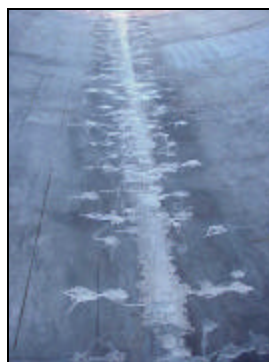
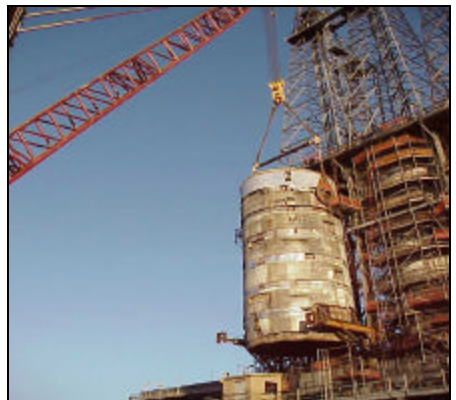
The site chose to use Chicago Bridge & Iron's "vertical plate" technology to replace the drums from tangent to tangent. The plate was manufactured in two sections—40

feet and 26 feet with only one horizontal weld where the two plates were joined. Eight vertical plates were welded together to form the drum.

The installation of these coke drums was quite unique and as such, the site has provided pictures to show how the drums were installed. We have included a few in this article. For more information on the vertical plate technology, please contact Coby Stewart with CBI at 281-765-3036.
